Still going strong

John Wickersham charts the life of his self-built motorhome's base vehicle

This month, I am going to provide a run-down of my own motorhome's 14-year life to date.

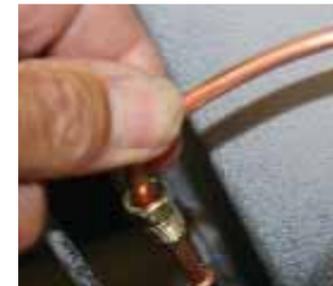
■ **Year 8 (2007)** – deep rusting on silencer boxes meant a new exhaust was required before the next MOT (above). Meanwhile, some of the original steel brake pipes needed replacing; good quality non-ferrous piping was fitted (right). Replacing other brake pipes almost became an annual job, probably hastened by winter driving on salted roads. In October, diesel exceeded £1 per litre.

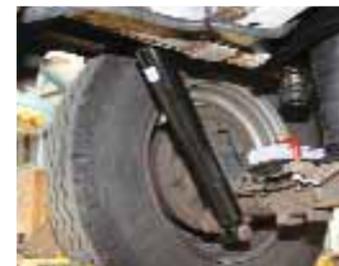
■ **Year 10 (2009)** – after fault-free period, a potentially dangerous event unexpectedly occurred at home on a cold February day. A rear suspension leaf-spring snapped (above). A flaw in the metal was clearly visible.

(Air suspensions are fitted on ambulances, buses, and lorries carrying sensitive loads like aero

engines. Failure of an air chamber's support spring through metal fatigue is highly unusual.) In March, a new VB air suspension was professionally installed (below left) which has performed perfectly ever since.

A replacement had to be traced in order to move the motorhome. A Sheffield spring specialist supplied one which I fitted at home as the opening photo shows.

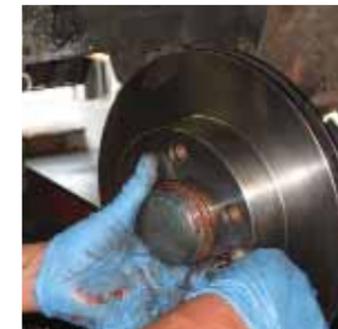
discs were needed after 11 years (below left). More surprising was the corroded sump (below right); finding a replacement for this Maxi took several days. Oil loss when driving can lead to serious engine damage.

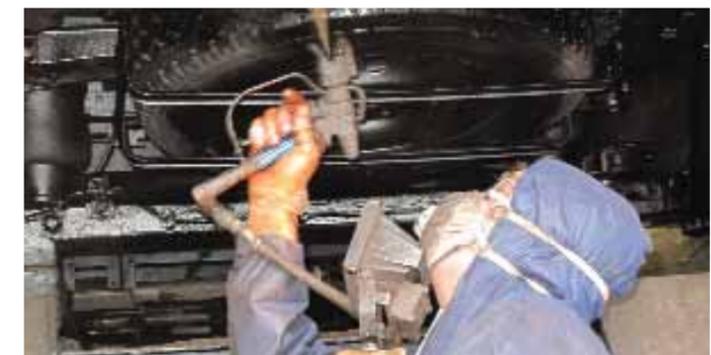
■ **Year 13 (2012)** – after a fault-free 2011, during which diesel exceeded £1.40 a litre, body panel corrosion was found in June 2013. Prior to an MOT, checks revealed that holes had appeared near the driver's cab door sill (right); welding work followed. A professional under-sealing operation was completed by Rust Busters (below) and reported in the September 2012 magazine. With hindsight,

under-sealing work should have been undertaken before holes started to appear in the cab.
