Still going strong

John Wickersham charts the life of his self-built motorhome's base vehicle

This month, I am going to provide a run-down of my own motorhome's 14-year life to date.

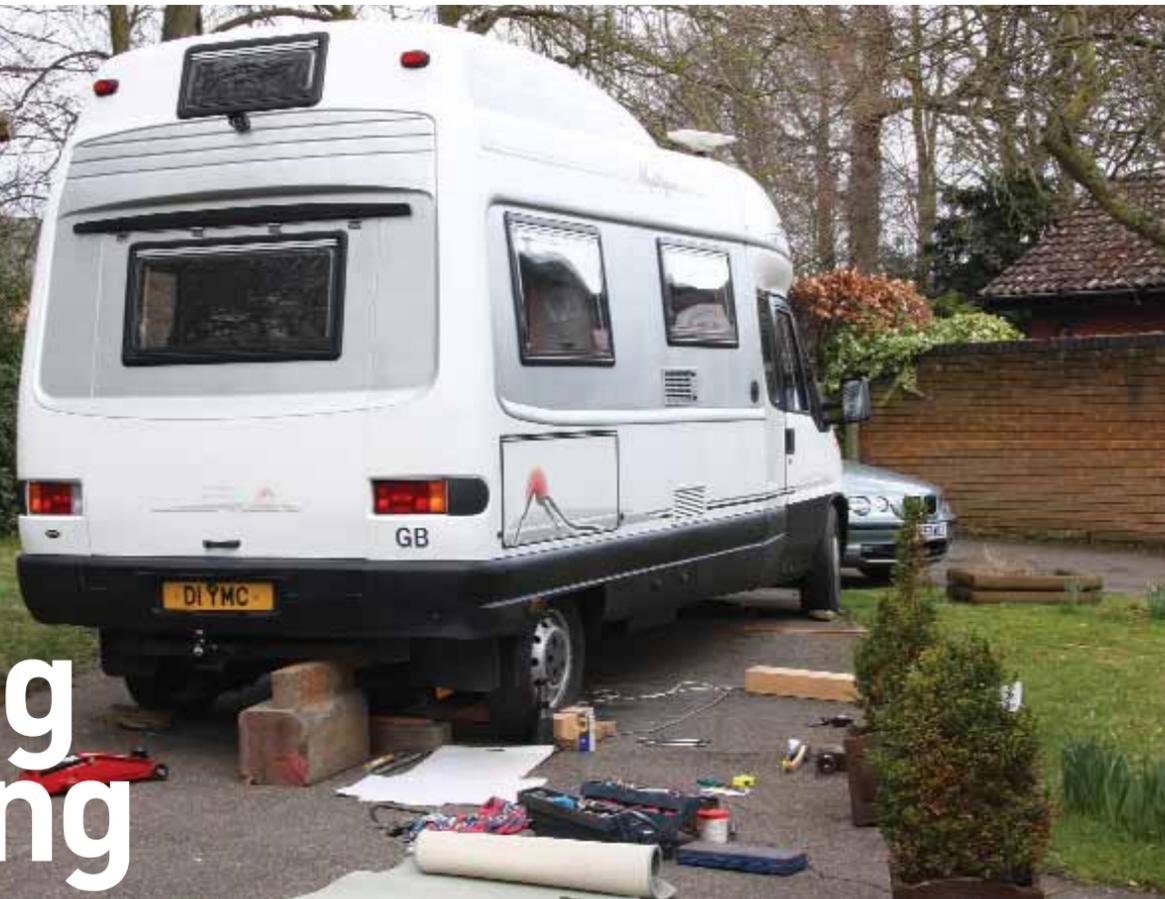
A replacement had to be traced in order to move the motorhome. A Sheffield spring specialist supplied one which I fitted at home as the opening photo shows.
