WEEKENDS AND A LITTLE WORK

The Bürstner Ixeo has had a busy month, booked out for weekends away and booked into Camper UK for a little work to be done

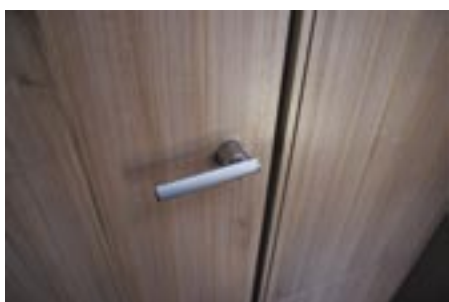
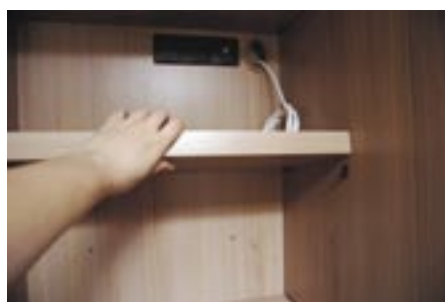
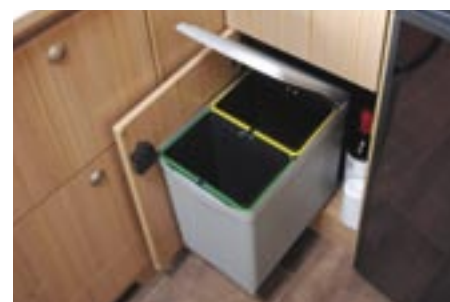
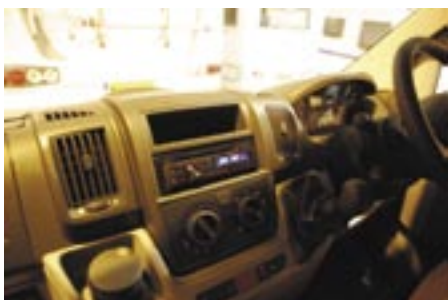
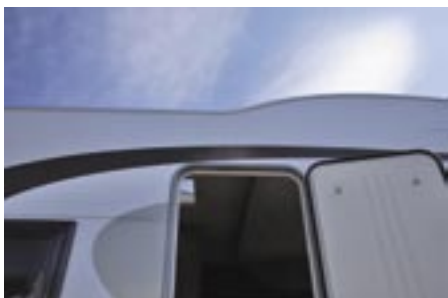
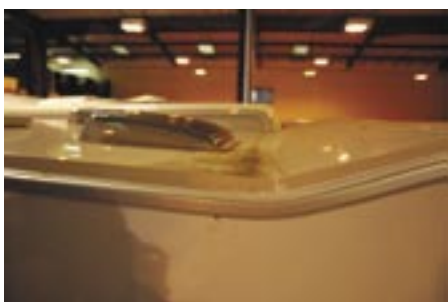
First, no washer fluid was coming out of the windscreen washers. We topped the washer tank up and checked the pipes for any blockages. We even inserted a pin into the end of the washer sprays to check they were not blocked, but, as it turned out, the pump was faulty so a new one is on order.

The washroom door handle had also become a little loose (wobbly), so Camper UK removed the handle, made and fitted plastic spacers and so put an end to the wobbles.

I'd also commented that the top wardrobe shelf could jump out of its small side fixings when on the move, especially if there was nothing on it. The technician took a look and fitted some adhesive tape to the back of all the shelves to provide extra resistance. The shelf now stays put.

Also, on another shelf, the front fascia was coming away from the wooden shelf base. The old adhesive was cleaned off and the fascia re-fitted with new adhesive.

I'd also noticed that the waste bin has never worked properly. This clever little bin (with two containers) should pull out from the cupboard, lid automatically raising as it does so. It did it once or twice, but the mechanism kept popping out.

The technician had to remove both bins and the lid. It was found that the rod that caused the lid to rise was too long. Cutting it down by 3mm has ensured the bin now works as intended.

Also, several users had noted that the radio kept pausing for a second, almost like a CD skipping. Camper UK replaced the radio, and the issue seems to have been resolved – proving

that the original radio must have had a fault.

One of our testers also noticed excessive smells coming through into the washroom from the toilet cassette, even with the correct amount of chemicals applied. The technician checked the cassette area and found that external flue pipe was not sitting snugly up to the plastic base, so he cut away the sealant to refit the flue pipe back into its correct position. The pipe was then resealed.
